**PRELIMINARY ASSESSMENT/
VISUAL SITE INSPECTION**

**FORD MOTOR COMPANY, MICHIGAN CASTING CENTER
FLAT ROCK, MICHIGAN
MID 058 819 822**

FINAL REPORT

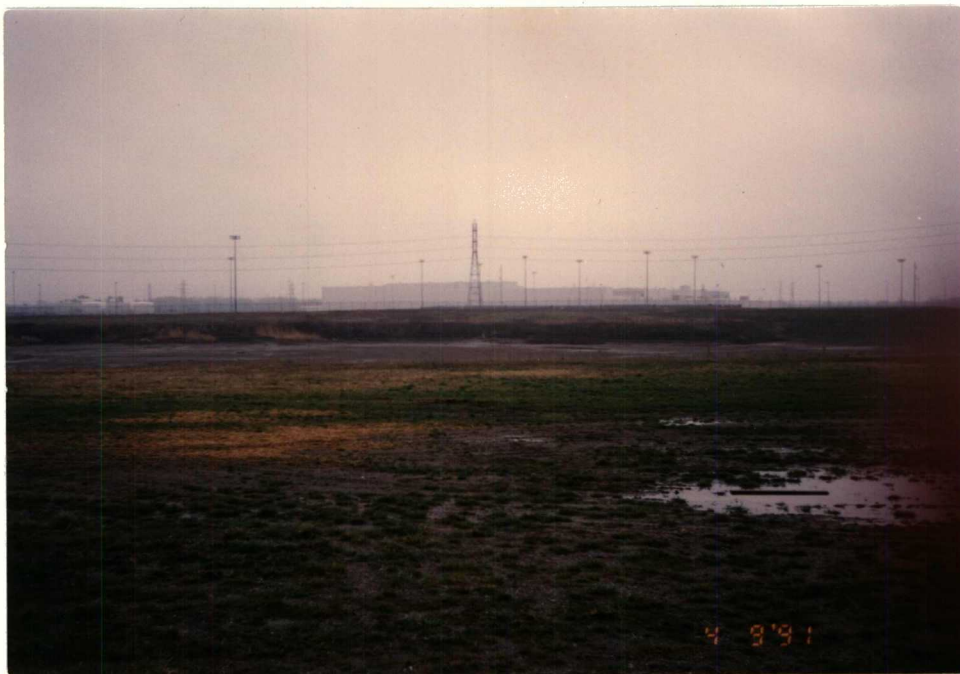
Photograph No. 1

Orientation: East

Location: SWMU 1

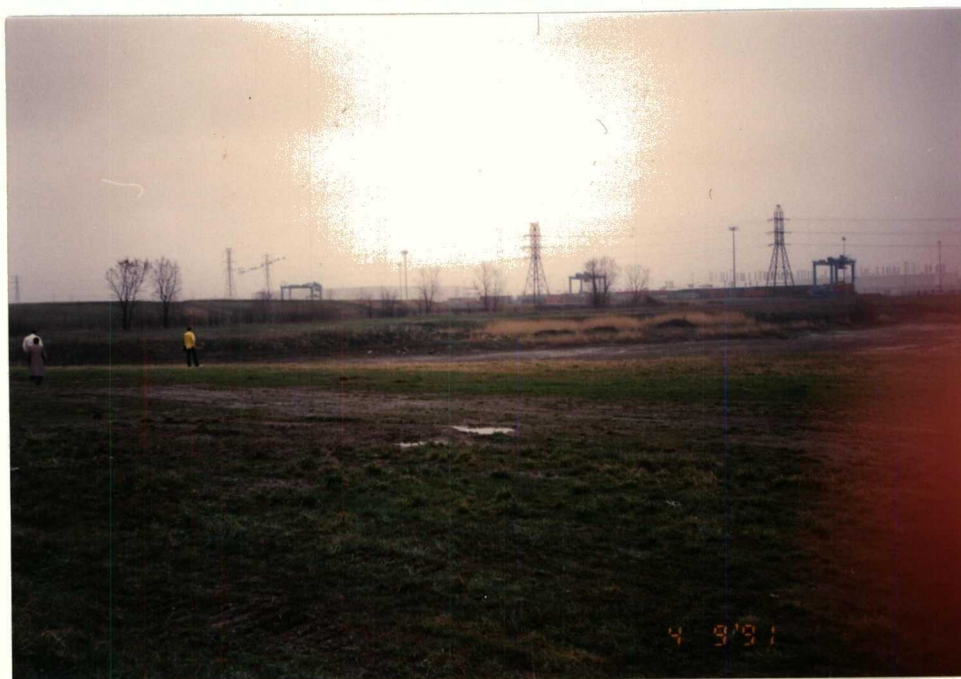
Photograph No. 2

Orientation: Northeast

Location: SWMU 1

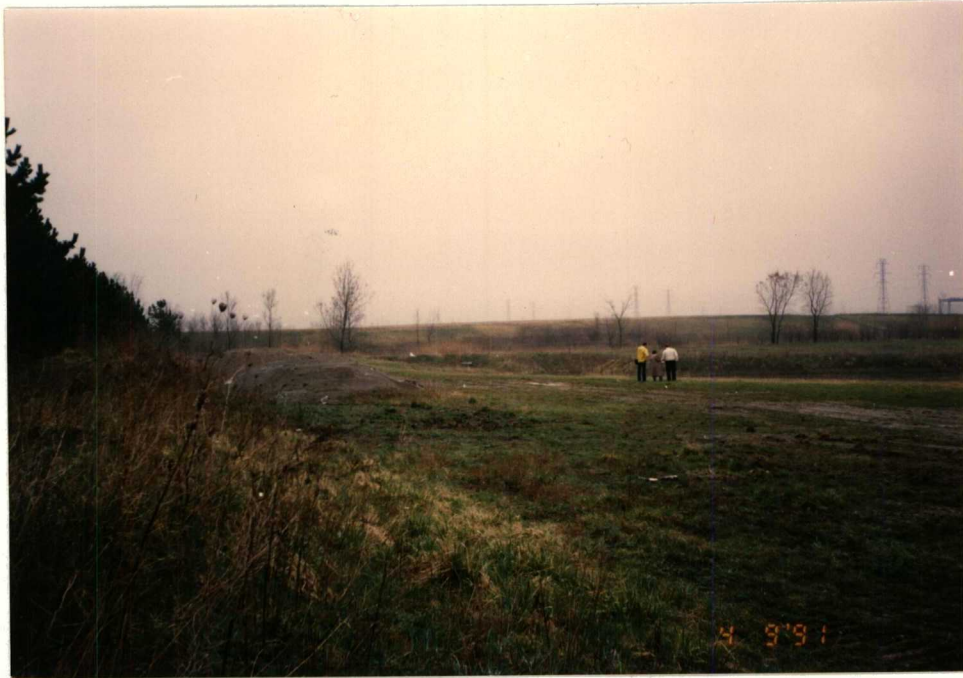
✓ Photograph No. 3
 Orientation: North
 Description: The middle of landfill Cell B on the west side

Location: SWMU 1
 Date: 04/09/91

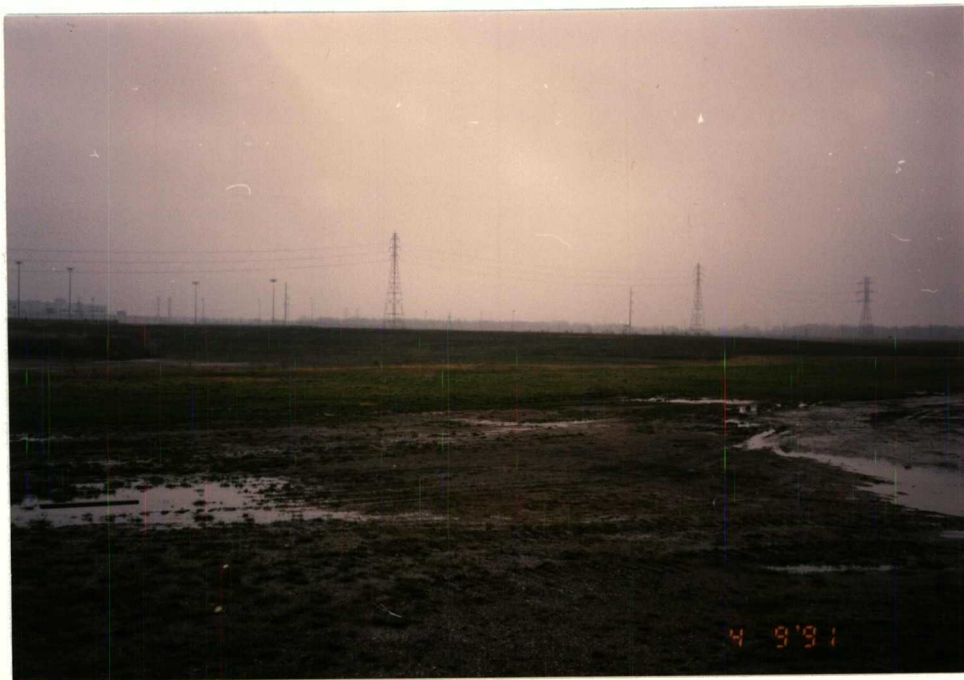
Observations: PRC did not observe any visible evidence of releases. During the VSI, PRC observed that Cell B had accumulated water in several sections; it is not known if the water was ground water or stormwater retention. A possible seep was observed west of Cell C that leads to Smith Creek (see Photo No. 8). Erosion was also observed at the middle of Cell D on the west side (see Photo No. 15). This area was covered with hay to reduce erosion.

Photograph No. 4
 Orientation: Southeast
 Description: The south side of landfill Cell B on the west side that contained ponded water

Location: SWMU 1
 Date: 04/09/91

Recommendations: The cause of the erosion at Cell D and the cause of water accumulation at Cell B should be investigated. The seep west of Cell C that leads to Smith Creek should also be investigated.

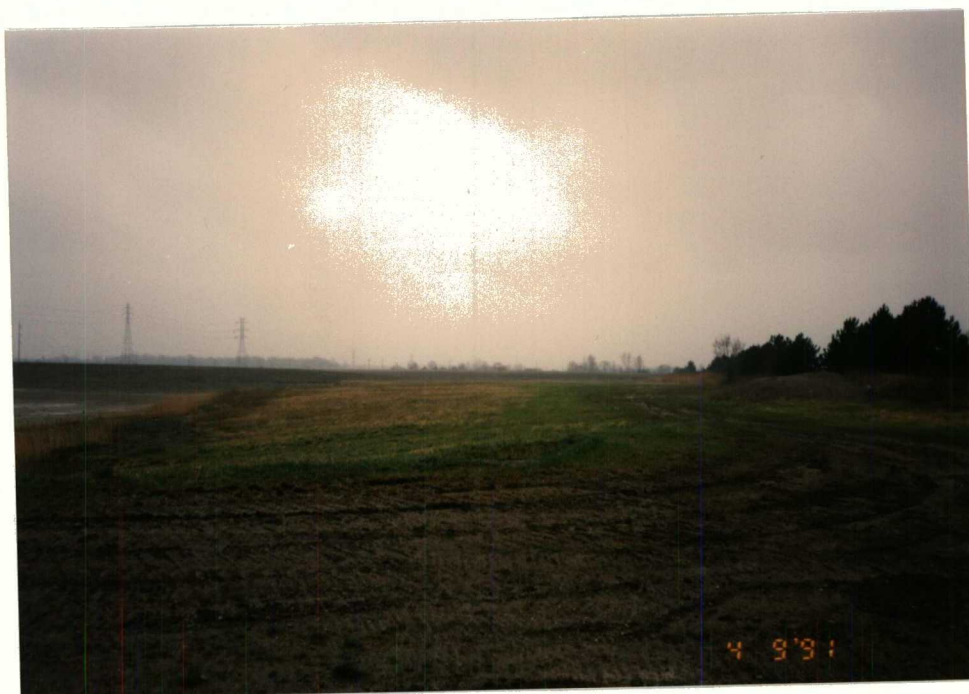
Photograph No. 7
 Orientation: South
 Description: The northwest corner of landfill Cell B

Location: SWMU 1
 Date: 04/09/91

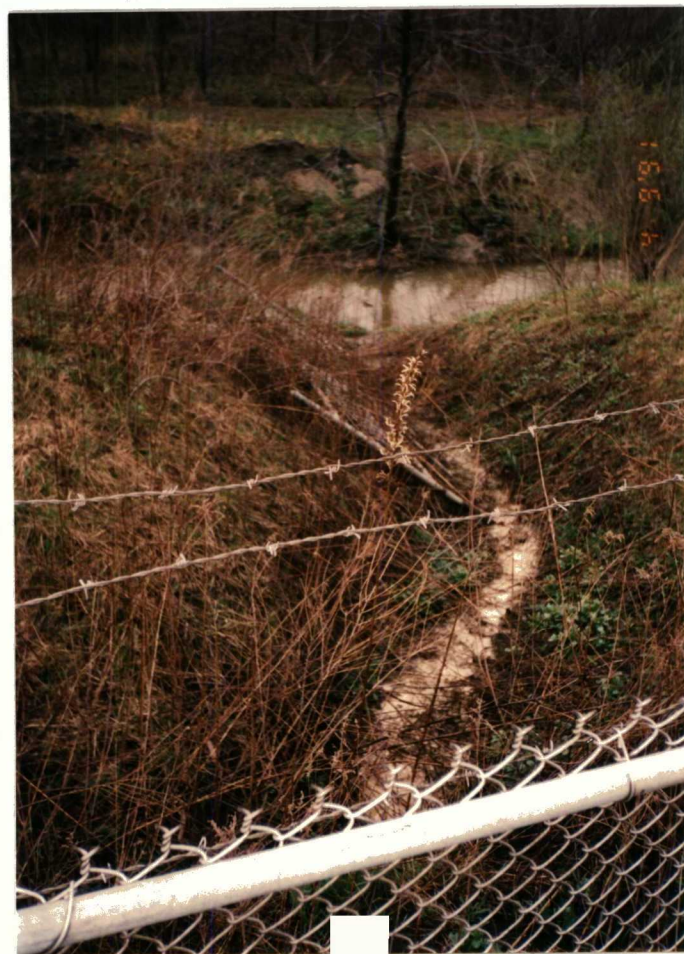
Surface Water: A moderate threat of surface water contamination exists from this SWMU. A seep was observed west of Cell C that flowed to Smith Creek. The chemical characteristics of the seep water is unknown.

Photograph No. 8
 Location: SWMU 1
 Orientation: Northwest
 Date: 04/09/91
 Description: A seep west of
 landfill Cell C
 that leads to
 Smith Creek

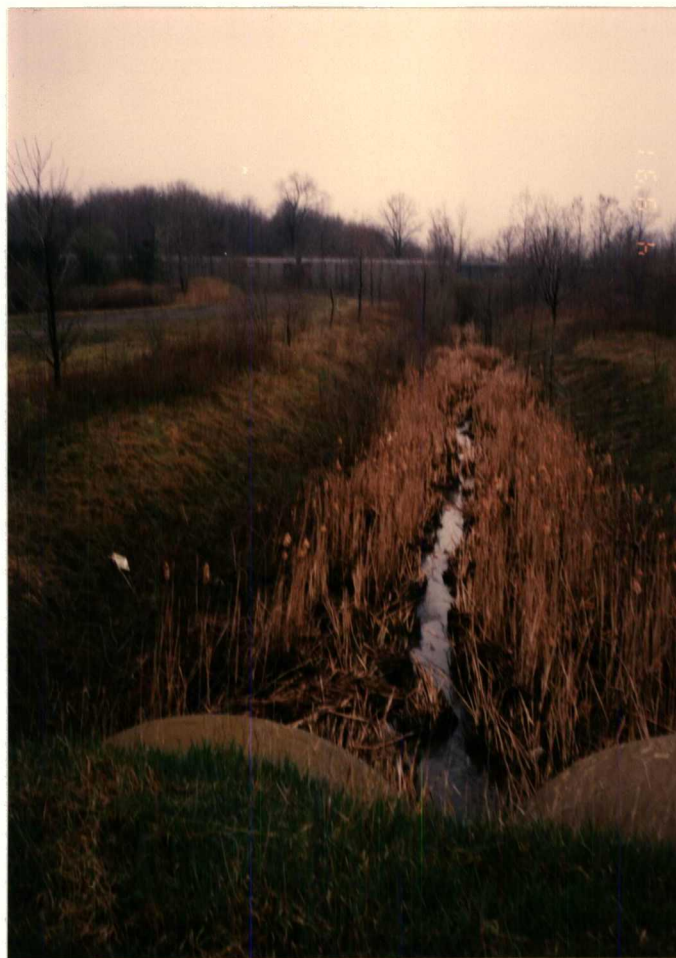
Photograph No. 9
Location: SWMU 1
Orientation: West
Date: 04/09/91
Description: A culvert about 700 feet
in length between landfill
Cell B and Cell C

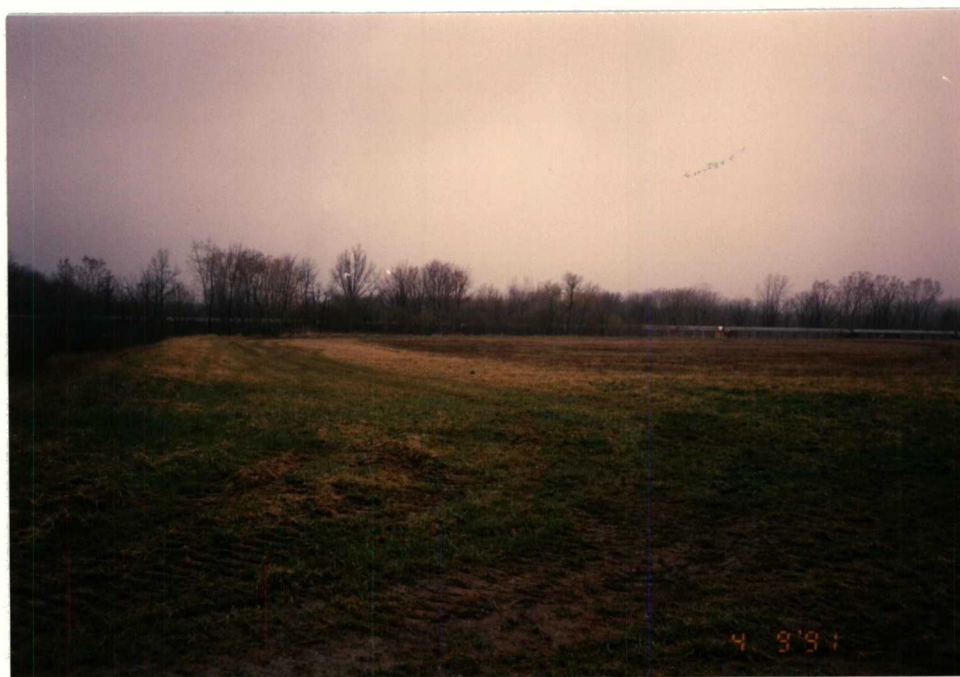
Photograph No. 10
Orientation: West
Description: The south of landfill Cell C in the middle

Location: SWMU 1
Date: 04/09/91

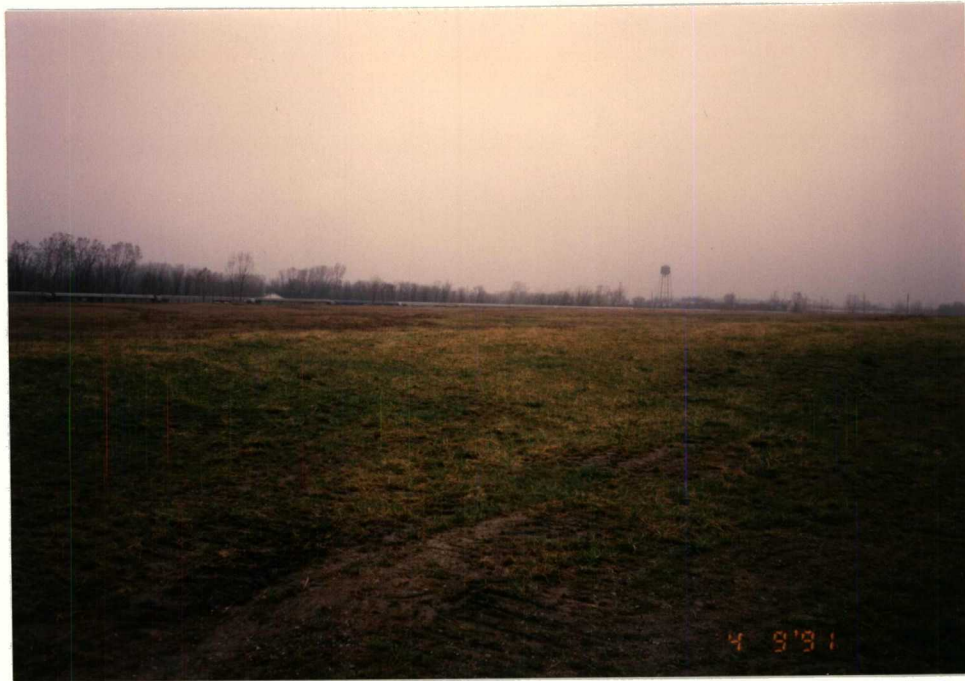
Photograph No. 11
 Orientation: Northwest
 Description: The middle of landfill Cell C on the south side

Location: SWMU 1
 Date: 04/09/91

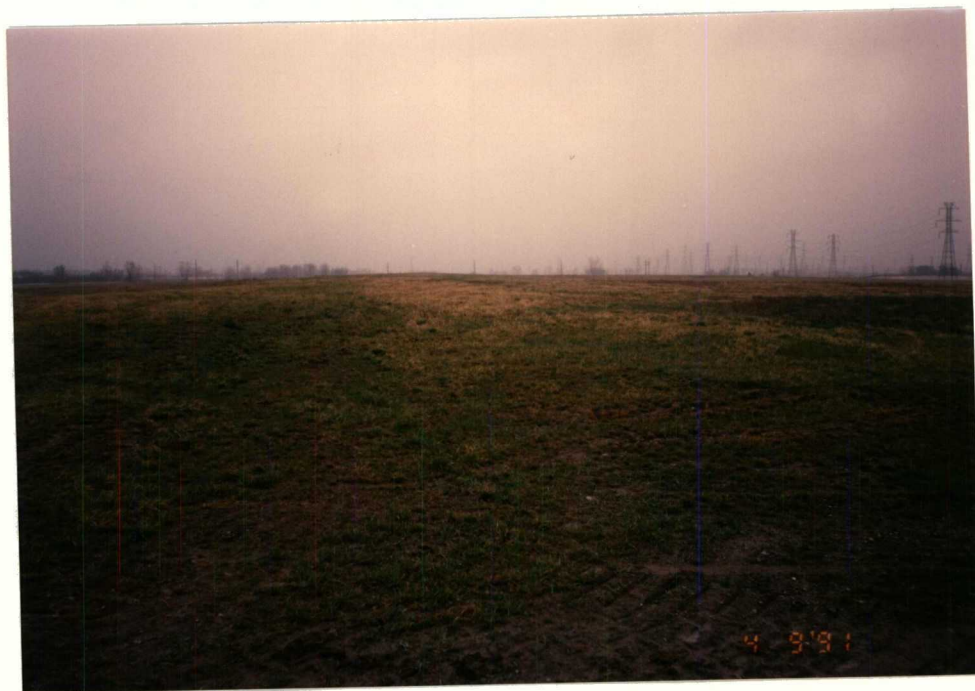
Photograph No. 12
 Orientation: North
 Description: The southeast side of landfill Cell C

Location: SWMU 1
 Date: 04/09/91

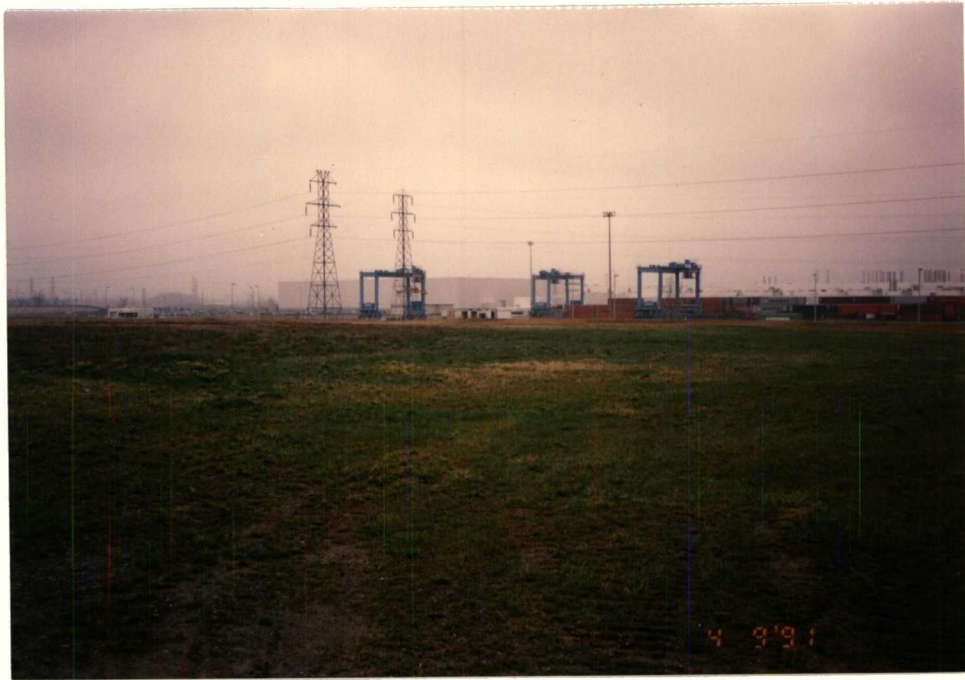
Photograph No. 13
 Orientation: Northeast
 Description: The southeast side of Cell C

Location: SWMU 1
 Date: 04/09/91

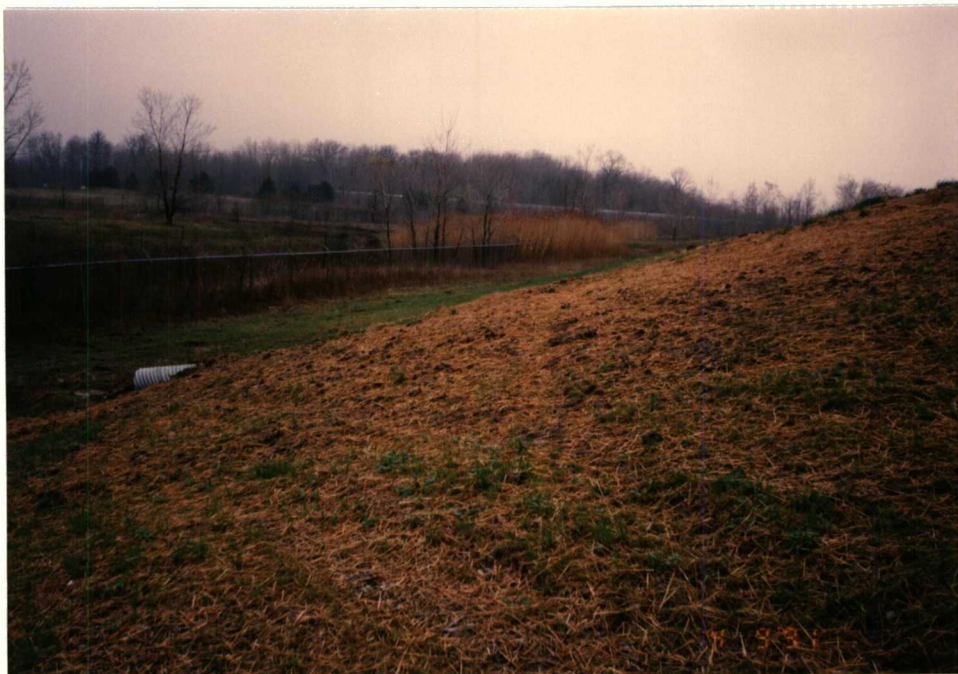
Release Controls: The unit was excavated to a depth of about 20 feet. The excavations were lined with clay and filled. Cells A, C, D, and E were completely filled with foundry wastes, including treated cupola baghouse dust and then capped. Cell B was not completely filled with treated cupola baghouse dust. Cells A, C, D, E, and part of Cell B were covered with 2 feet of clay, graded, and seeded. About six drainage pipes were installed to direct precipitation from the top of the landfill and prevent erosion (see Photo No. 14).

Photograph No. 14
 Orientation: Southeast
 Description: Drainage pipe for prevention of erosion at the southeast corner of landfill Cell C

Location: SWMU 1
 Date: 04/09/91

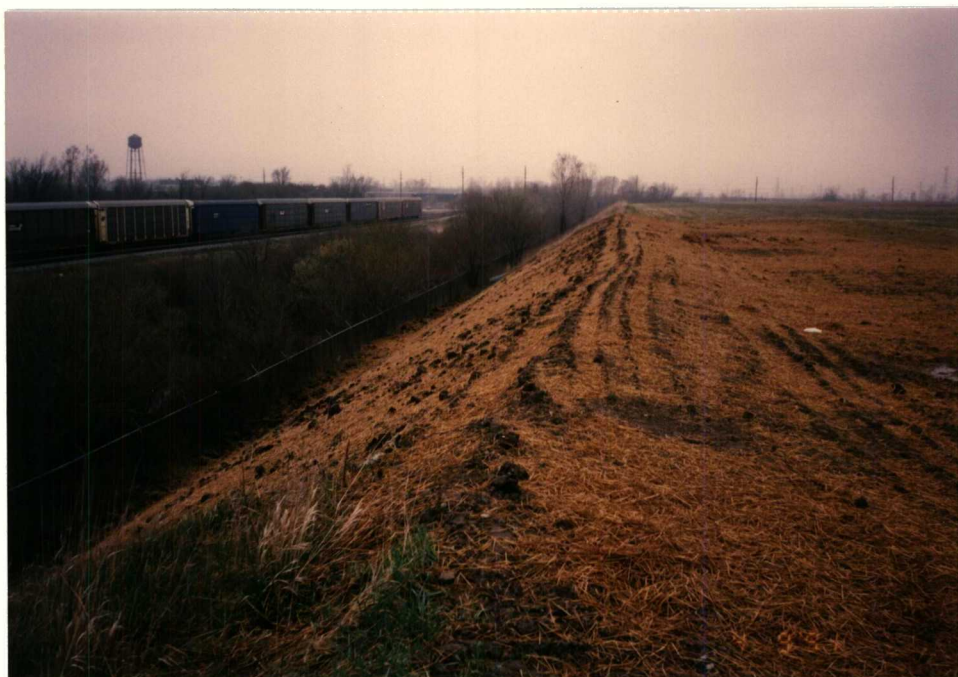
On-site soil: A moderate threat of soil contamination exists from this SWMU. Erosion was observed near Cell D.

Photograph No. 15
 Orientation: North
 Description: Erosion on west side of landfill Cell D in the middle

Location: SWMU 1
 Date: 04/09/91

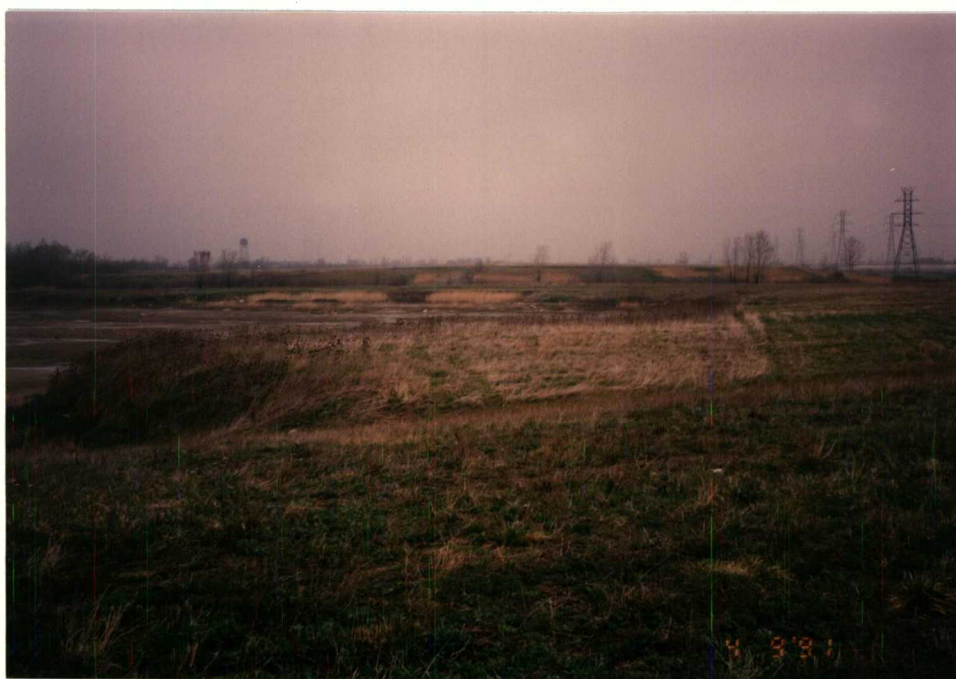
Photograph No. 16
 Orientation: North
 Description: Capped portion of landfill Cell B on the southeast corner

Location: SWMU 1
 Date: 04/09/91

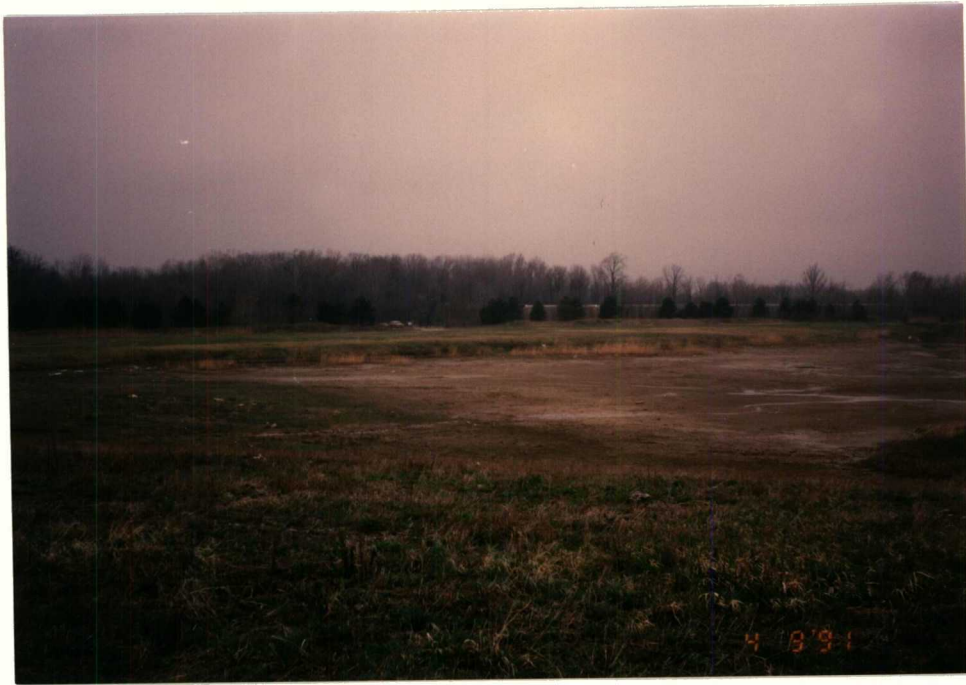
Photograph No. 17
Orientation: Northwest
Description: Capped portion of landfill Cell B on the southeast corner

Location: SWMU 1
Date: 04/09/91

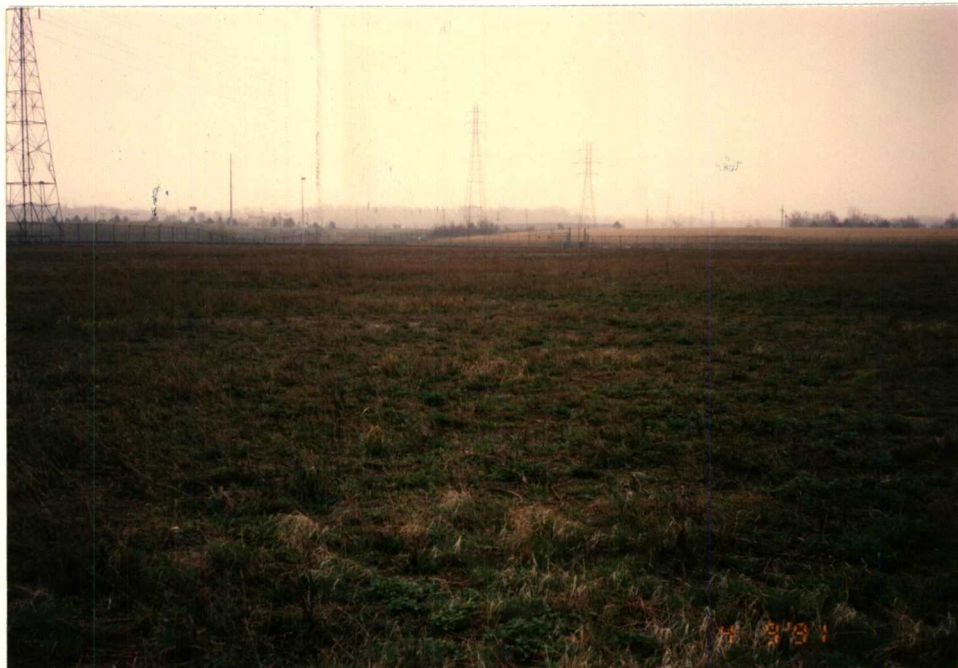
Photograph No. 18
Orientation: Southeast
Description: Capped portion of landfill Cell B on the southeast corner

Location: SWMU 1
Date: 04/09/91

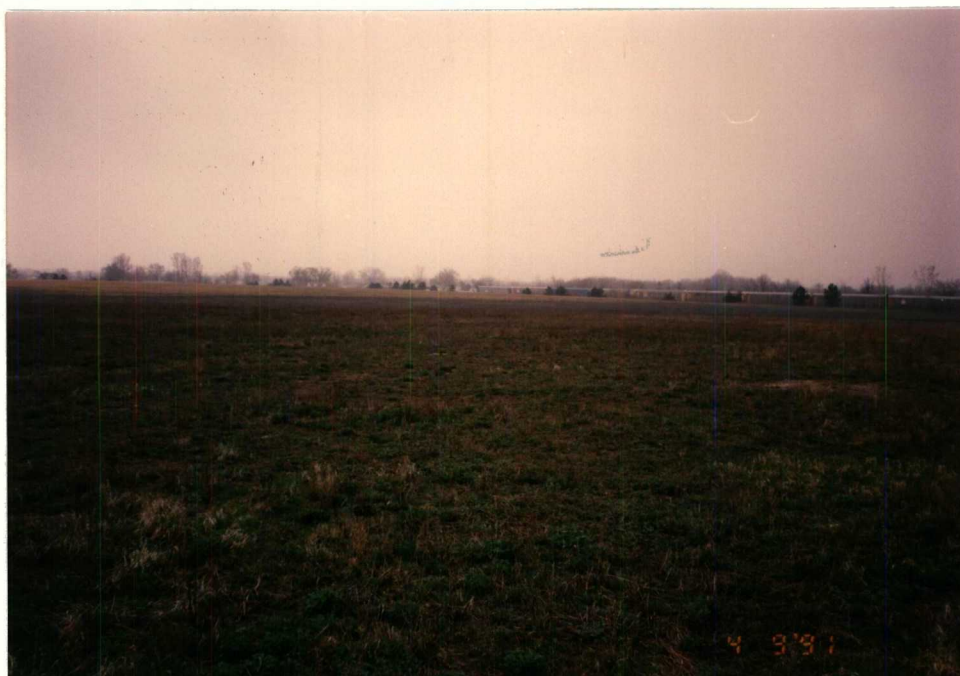
Photograph No. 19
 Orientation: Southwest
 Description: Capped portion of landfill Cell B on the southeast corner

Location: SWMU 1
 Date: 04/09/91

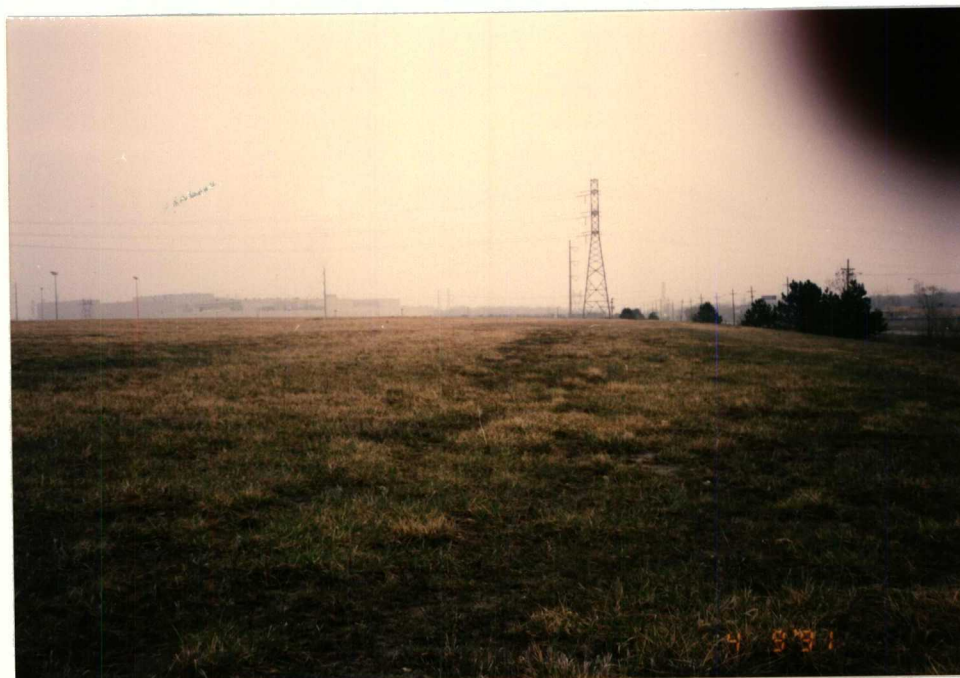
Photograph No. 20
 Orientation: East
 Description: The southwest corner of landfill Cell A

Location: SWMU 1
 Date: 04/09/91

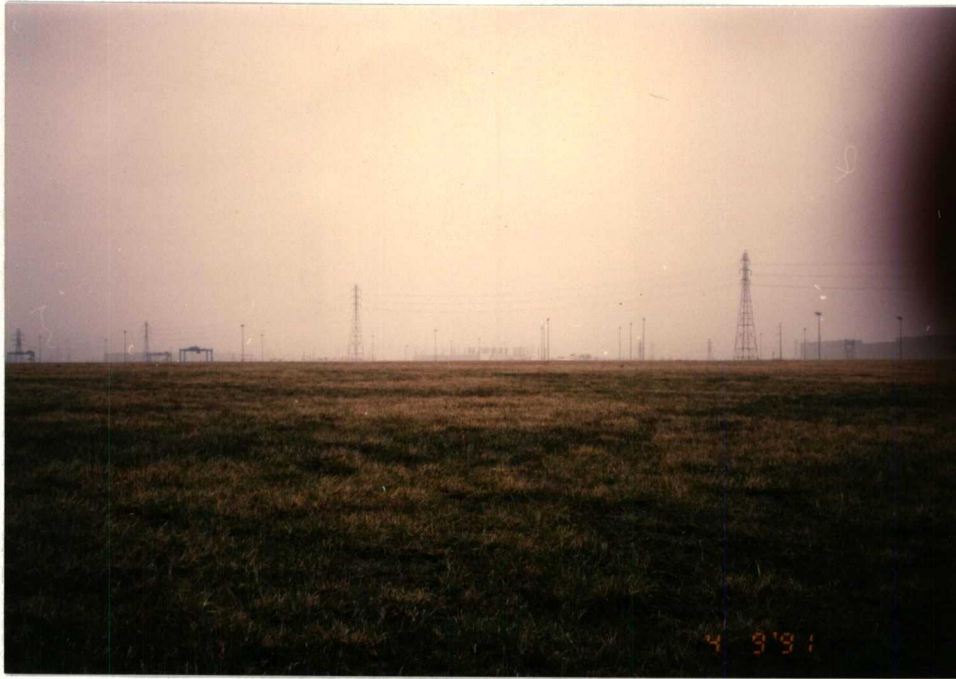
Photograph No. 21
 Orientation: Northeast
 Description: The southwest corner of landfill Cell A

Location: SWMU 1
 Date: 04/09/91

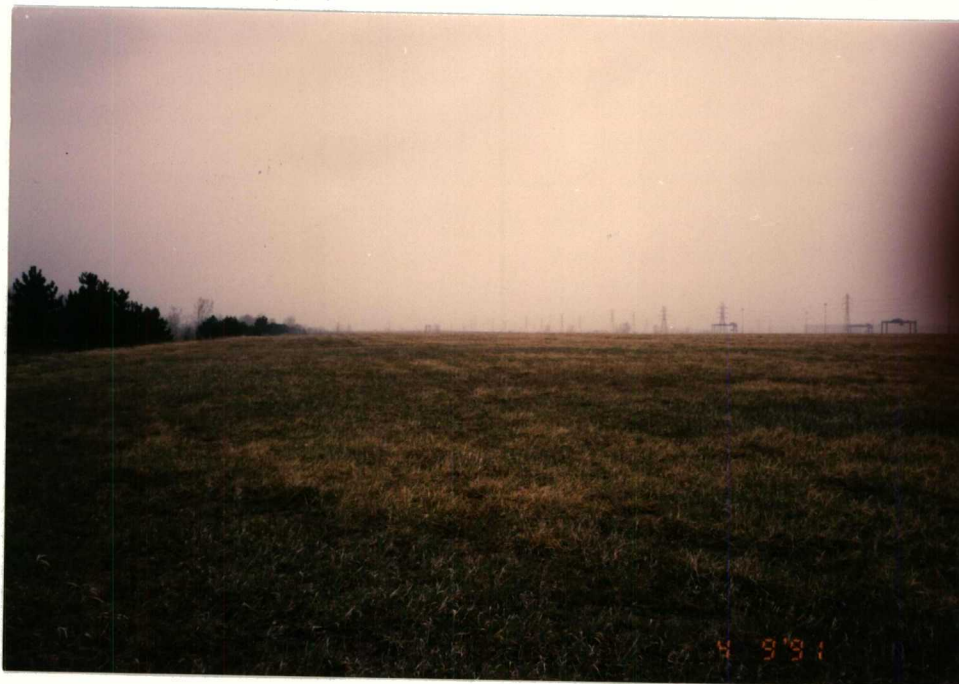
Photograph No. 22
 Orientation: North
 Description: The southwest corner of landfill Cell A

Location: SWMU 1
 Date: 04/09/91

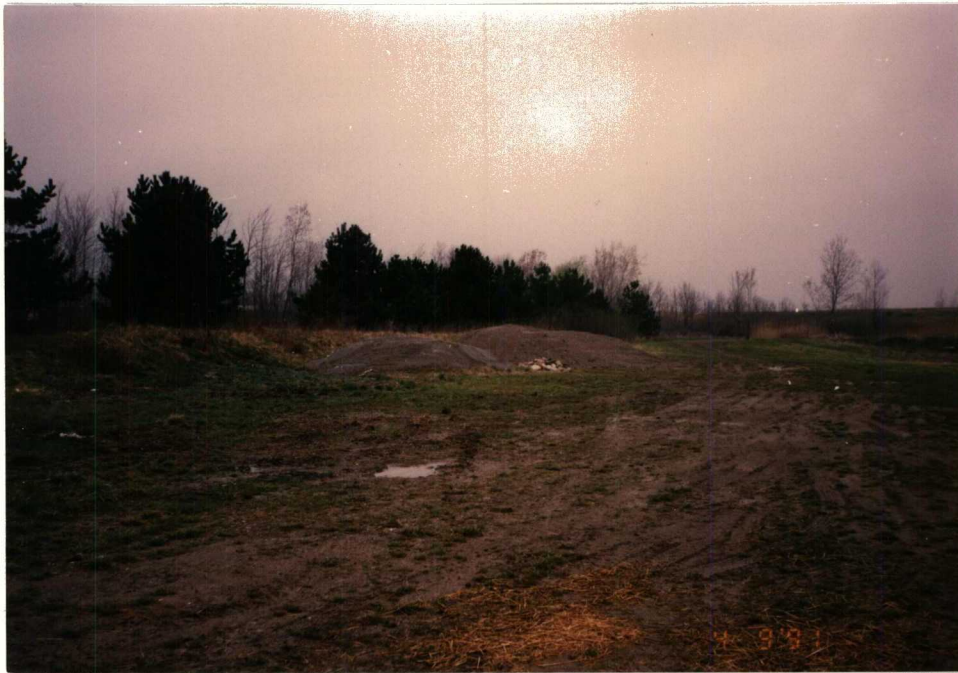
Photograph No. 23
 Orientation: North
 Description: Middle of western side of landfill Cell B

Location: SWMU 1
 Date: 04/09/91

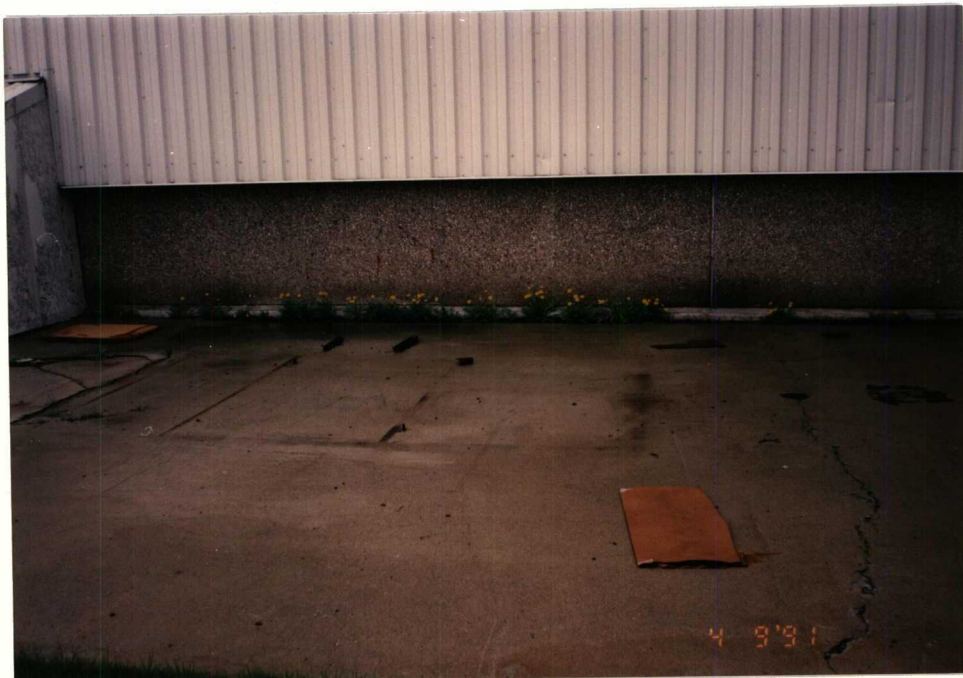
Observations: The exact location of the unit is not known. Approximate areas where the unit may have been located were inspected, and PRC observed no indication that a release had occurred in the past.

Photograph No. 24
 Orientation: Southwest
 Description: Possible former location of Outside Container Storage Area east of the MCC Building

Location: SWMU 2
 Date: 04/09/91

Recommendations: No sampling or monitoring is needed at this time.

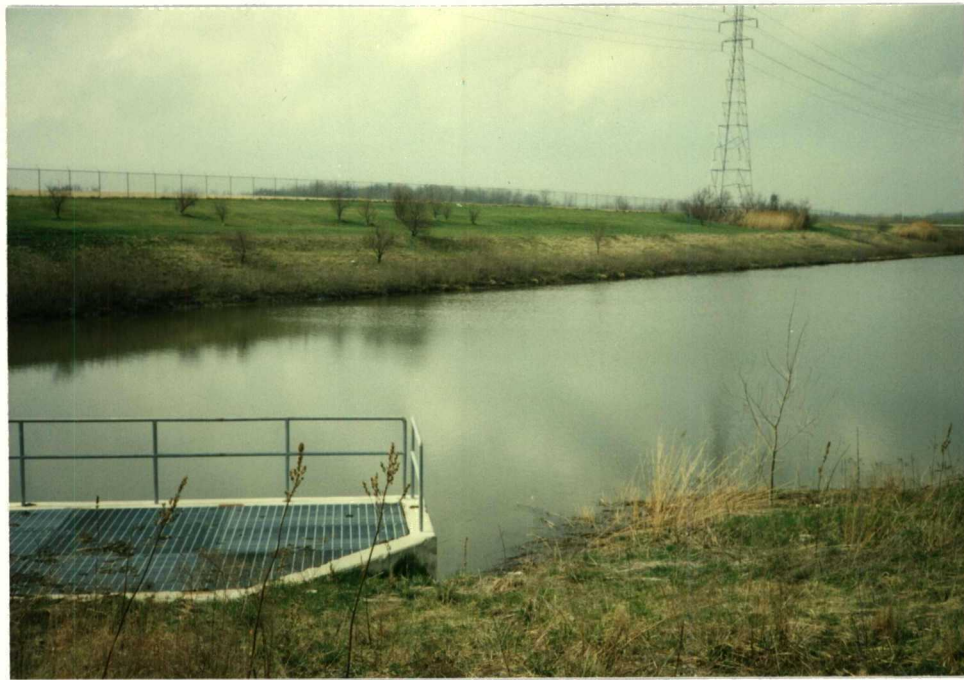
Photograph No. 33
Orientation: Northwest
Description: Southeast corner of stormwater retention pond near inlet

Location: AOC 2
Date: 04/09/91

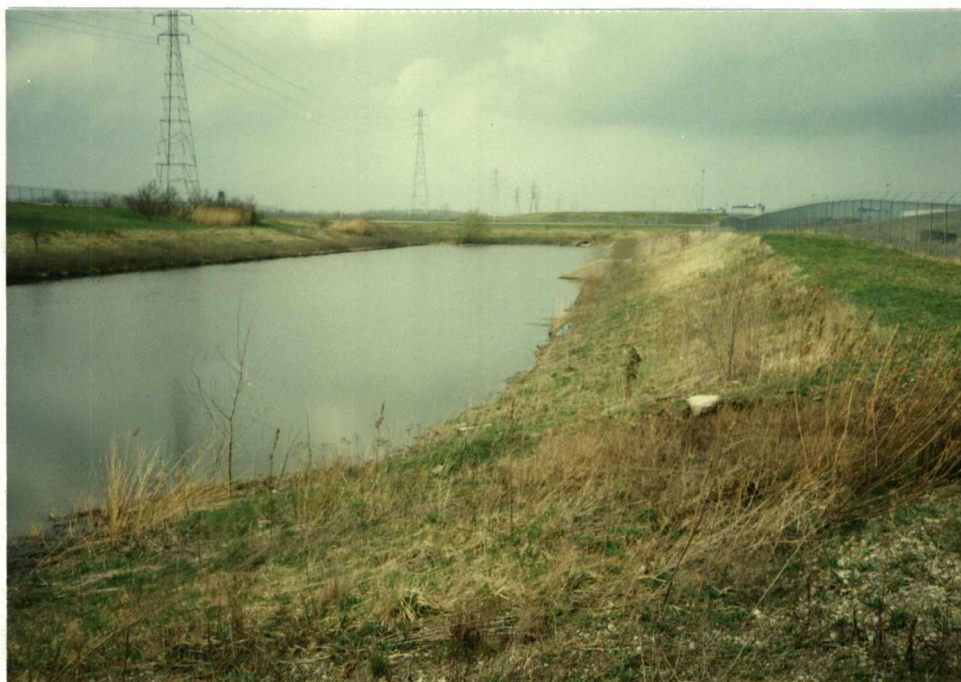
Photograph No. 34
Orientation: North
Description: Southeast corner of stormwater retention pond near inlet

Location: AOC 2
Date: 04/09/91

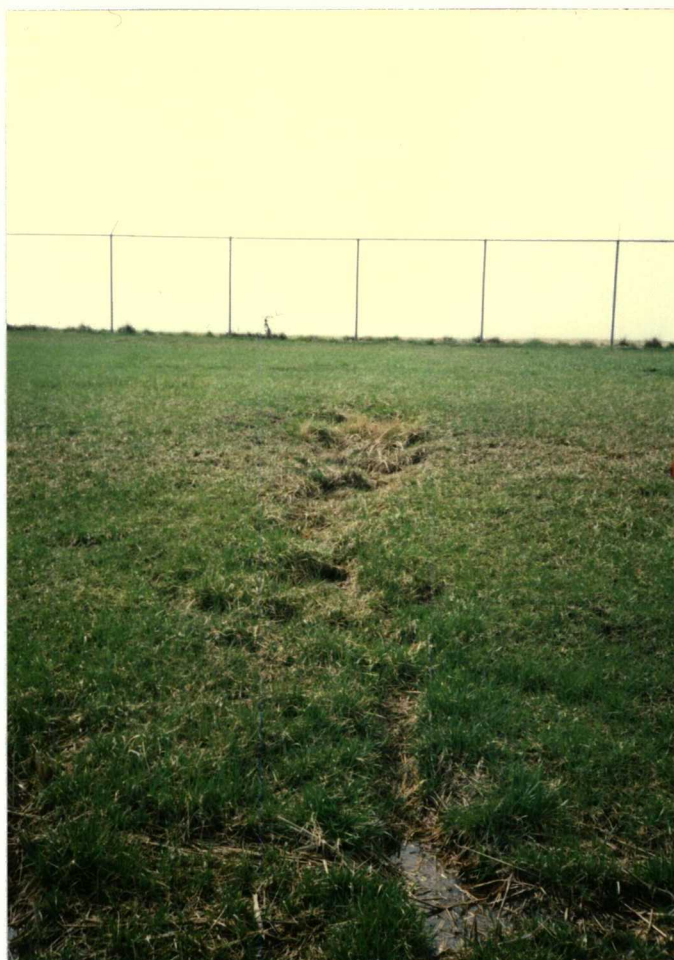
On-site soil: A low threat of soil contamination exists from this AOC. The water in the stormwater retention pond has direct contact with the soil. A small seep was also observed on the west side of the stormwater retention pond.

Photograph No. 35
Location: AOC 2
Orientation: West
Date: 04/09/91
Description: Small seep from the
landfill on west
side of stormwater
retention pond

Recommendations: Water quality and on-site soils should be characterized. The cause of the small seep should be investigated.

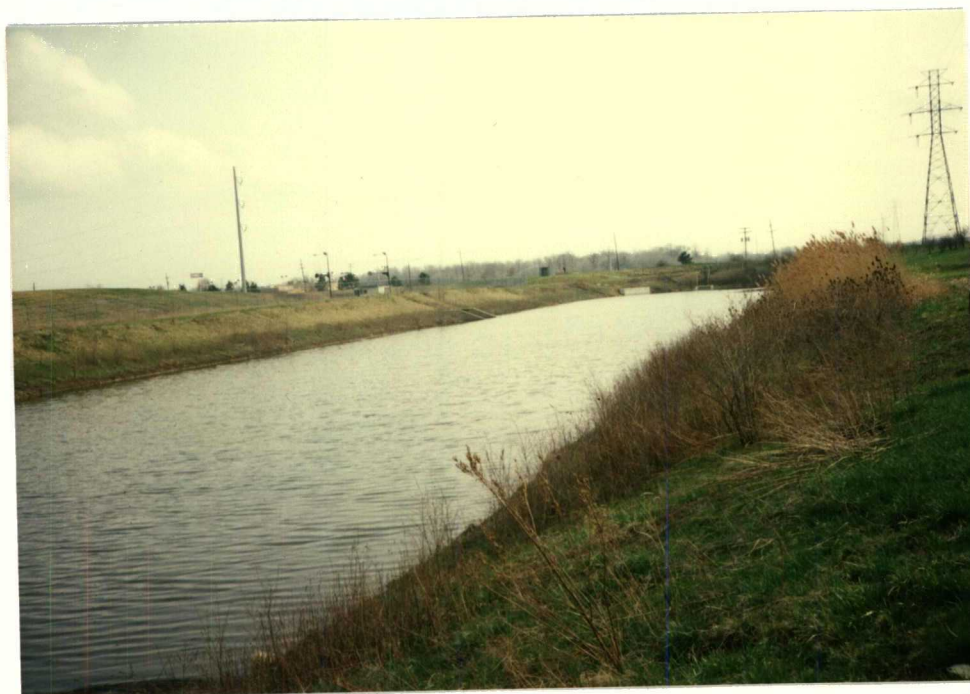
Photograph No. 36
Orientation: South
Description: Northwest corner of stormwater retention pond

Location: AOC 2
Date: 04/09/91
